INSPECTOR GENERAL

SEPTEMBER 30, 2016

Military Housing Inspection - Camp Buehring, Kuwait

SUBJECT: Military Housing Inspection - Camp Buehring, Kuwait (Report No. DODIG-2016-139)

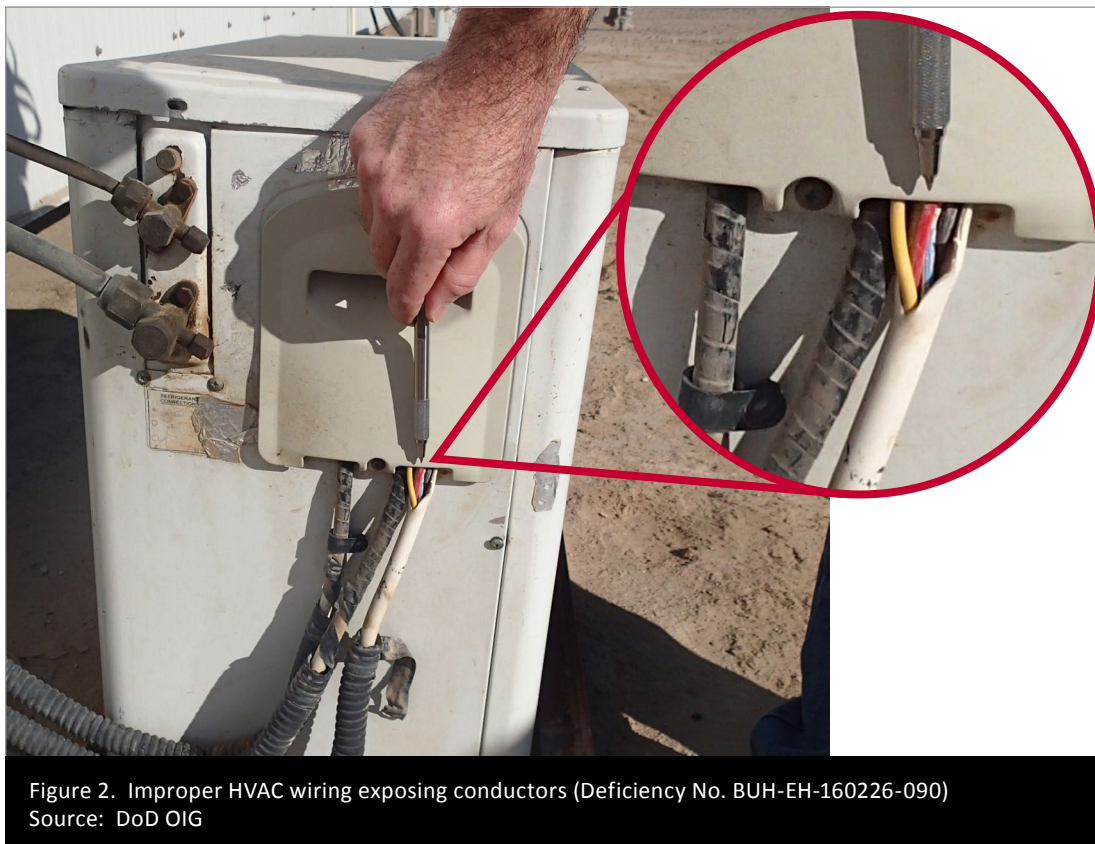
We found that electrical equipment installation and maintenance at Camp Buehring had not been performed in a manner consistent with the National Electrical Code (NEC). We identified 34 instances of improper attachment of electrical wires to heating ventilation and air conditioning (HVAC) units and outdoor lighting fixtures. These wires are required to have sheathing or flexible conduit secured

inside the HVAC unit or electrical box. The improper attachment of these wires exposes live conductors to the elements and increases potential for damage to insulation (Figure 2). This increases the risk of electrical shock or electrocution.

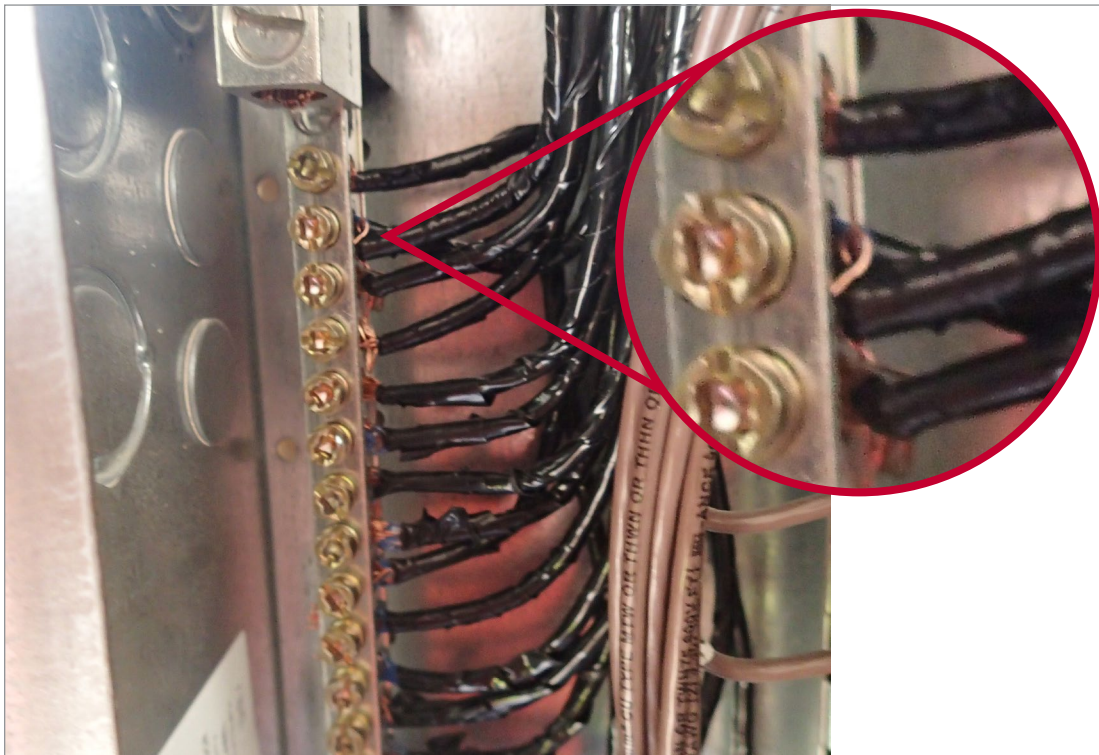
We also inspected new housing constructed under KEEP. These buildings are energy efficient, relocatable billeting designed to reduce power consumption through R-25 insulation in the walls, floor, and roof. Additionally, some KEEP buildings have rooftop solar array panels to supplement power generated onsite. Electrical panels installed in new KEEP buildings had electrical components, which were used beyond their design capacity. These panels have neutral busbars without enough terminals to allow each neutral conductor to be connected to its own terminal, as required. Therefore, instead of using a properly sized busbar, the installers put two neutral conductors under busbar terminals meant for only one conductor (Figure 3). A busbar is a thick strip of metal that allows multiple electrical connections and conducts electricity within an electrical panel. The size of the busbar is important in determining the maximum amount of current it can safely carry. Attaching more conductors to a busbar than it was designed to carry may increase the electric current beyond its design capacity causing it to overheat and increase the risk of fire.

Figure 3. Two neutral conductors under busbar terminals meant for only one conductor (Deficiency No. BUH-EL-160226-147)
Source: DoD OIG

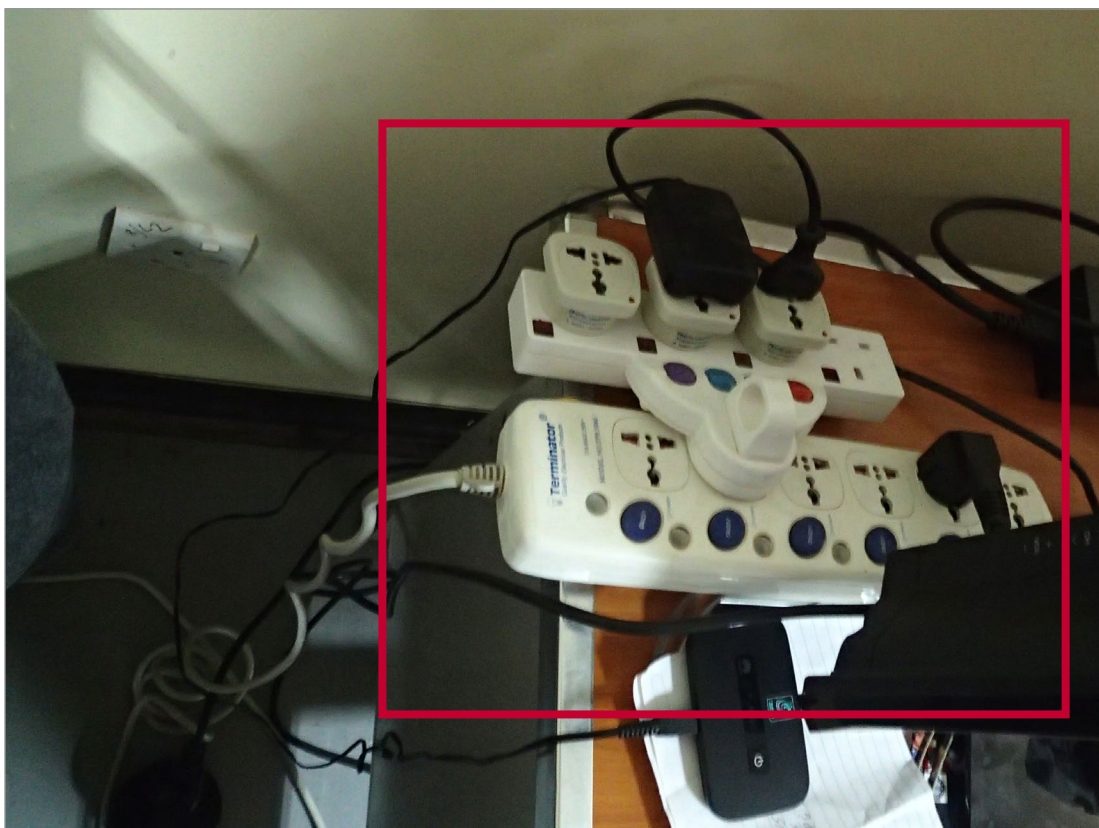
Tenants engaged in unsafe practices with electrical cords and electrical devices. We found 13 examples where tenants in housing and administrative areas daisy chained power cords and transformers (Figure 4). Daisy chaining electrical power strips together can result in overloaded and overheated power cables increasing the risk of fire. Tenants used transformers that were not approved by a recognized safety laboratory, such as UL or Conformité Européenne. Tenants connected American-style power cords approved for 125 volts to British-style 220-volt receptacles, making it easy to exceed the approved power rating of an extension cord or appliance. Also, heat-generating appliances, such as coffee makers and microwave ovens, were often found in sleeping quarters. The use of unapproved electrical devices or devices not used in accordance with their approved design are at a higher risk for malfunction resulting in shock, fire, or electrocution.

Figure 4. Daisy chained transformer and power cords (Deficiency No. BUH-EL-160226-024)
Source: DoD OIG

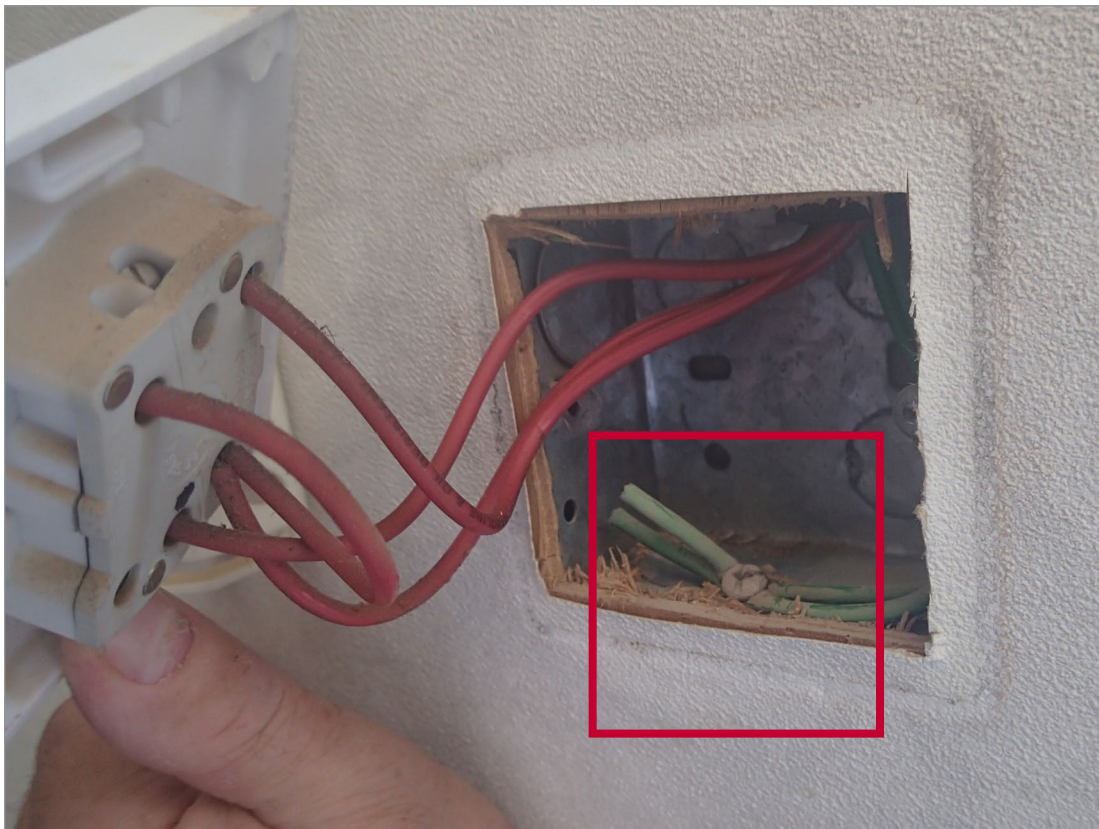
For grounding and bonding deficiencies, we found eight light switches and outlet receptacles in the trailers without proper equipment grounding. Also, light switches in the trailer park-style housing were improperly grounded due to a manufacturing defect. Instead of the wires being properly wrapped around the screw, or an appropriate wire termination lug applied, the ground wires were simply connected to the metal box by a sheet metal screw driven through the insulated ground wire conductors (Figure 5). This unapproved method fails to guarantee a secure ground and can leave a receptacle without proper equipment grounding, thereby increasing the risk of shock or fire.

Figure 5. Improperly grounded light switch (Deficiency No. BUH-EL-160226-056)
Source: DoD OIG

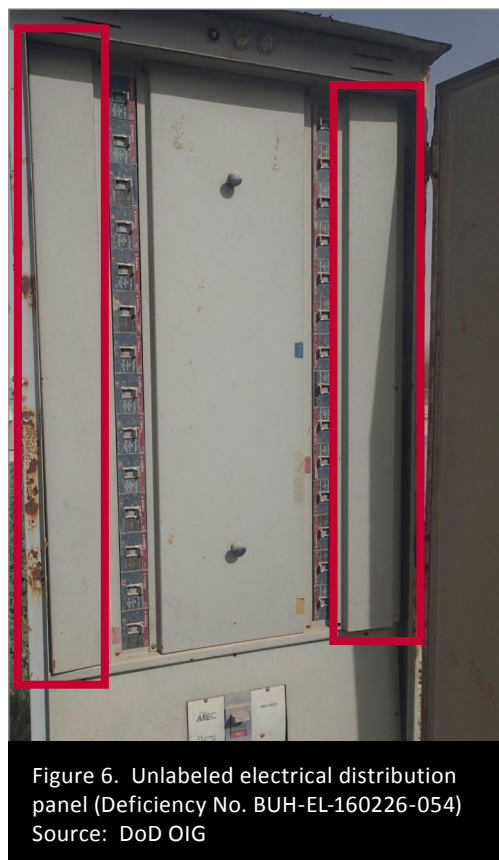
For equipment accessibility and labeling, we found blocked access to electrical panels and 11 instances where electrical panels were not properly labeled identifying the facility to which it supplied power. These panels were also missing proper labeling describing the function of their individual circuits (Figure 6). This lack of information presents a shock or electrocution hazard in an emergency situation where a circuit may need to be de-energized.

Figure 6. Unlabeled electrical distribution panel (Deficiency No. BUH-EL-160226-054)
Source: DoD OIG

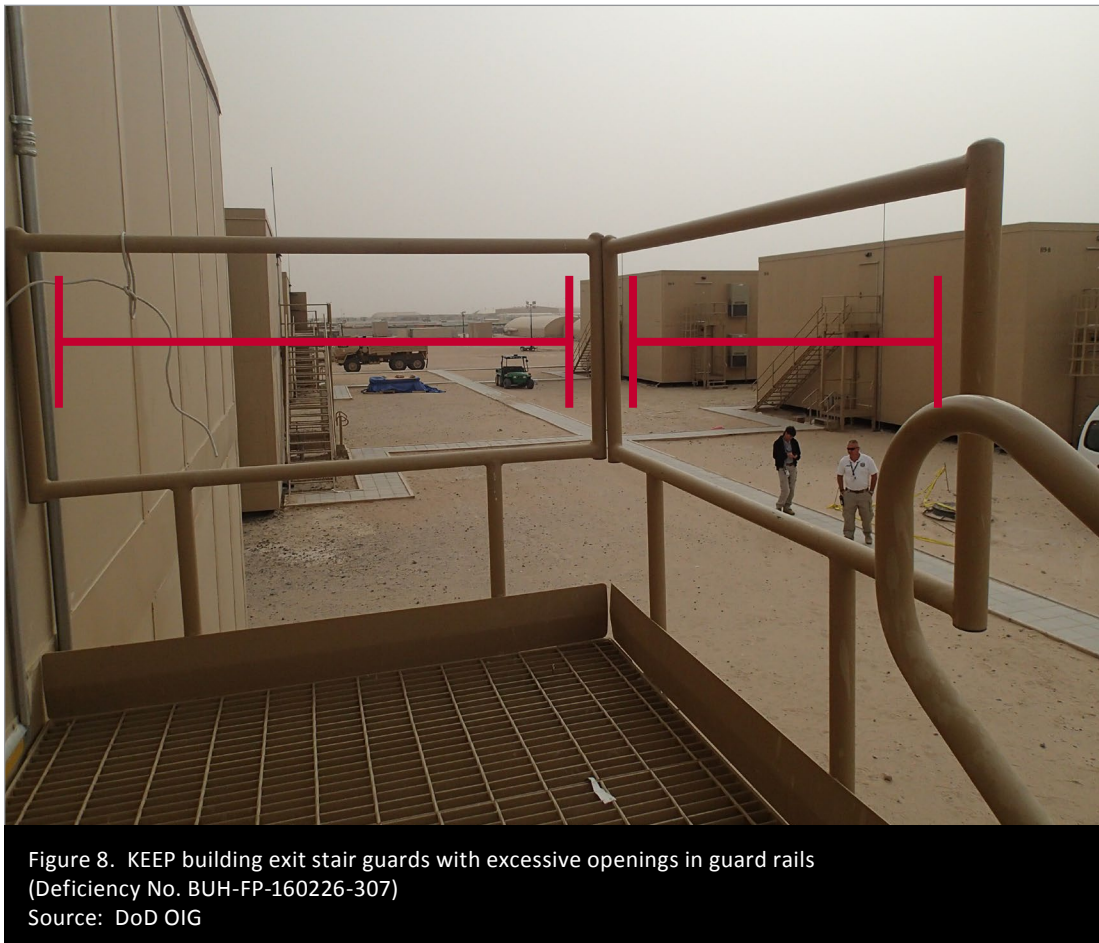
Means of egress available for immediate use by occupants is required by NFPA 101. Inadequate means of egress could inhibit occupants' ability to escape in the event of fire, leading to injury or death. We found 31 exit stairs external to the barracks without handrails. The lack of handrails on exit stairs makes it difficult to navigate the stairs and can also contribute to a loss of balance and falls while going up or down the stairs. This deficiency was identified in 30 facilities. Also, we found 38 exit stairs with stair risers of inconsistent dimensions. For instance, the height of the first and last stair would be different than the height of the remaining stairs. Inconsistent riser dimensions inhibit means of egress as they are difficult to navigate and can create a tripping hazard to users. We found newly installed guard rails at the KEEP buildings that have excessive openings in the ornamental pattern (Figure 8). This was found at a building that had been accepted by the U.S. Government. Guard rails are to be arranged such that the ornamental pattern does not permit a sphere four inches or greater in diameter to pass through any opening in the guard rail extending up to a height of 34 inches above the landing, stair, or floor. Improperly designed guard rails can present a fall through hazard for personnel using the stairs.

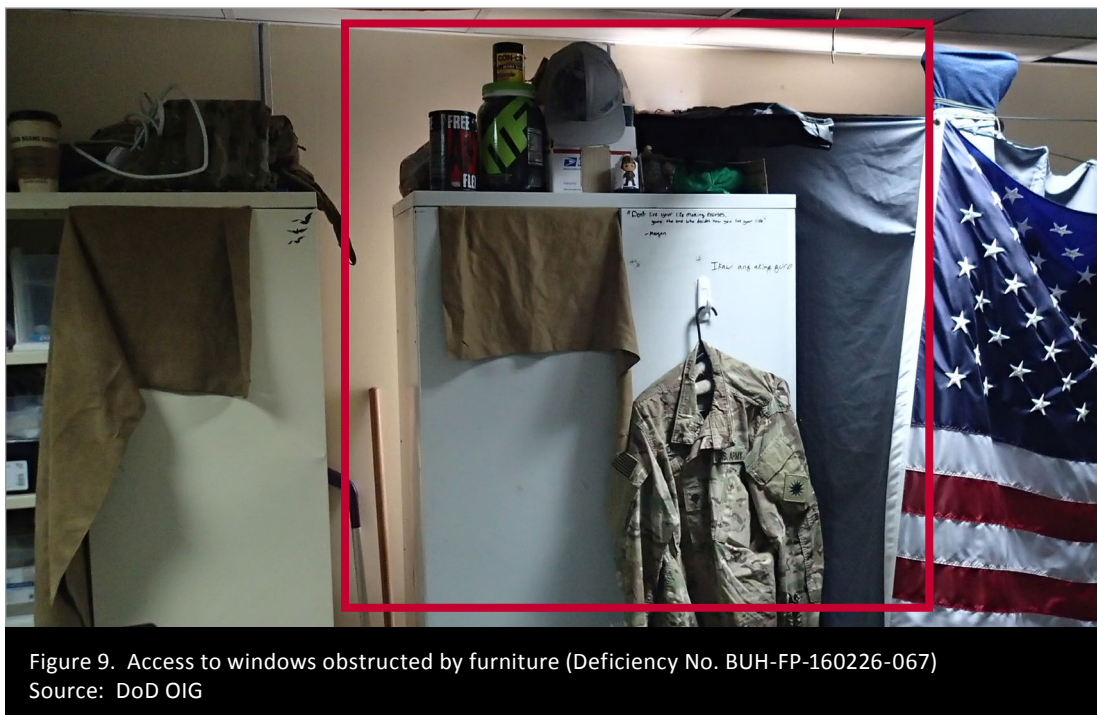
We found 15 windows in 11 barracks sleeping areas with fixed (bolted) bars across each window. We also found eight windows blocked by furniture (Figure 9). The required secondary means of escape is rendered unusable when windows are blocked by non-removable bars or furniture. If a fire blocks the primary means of egress (for example, the door to the corridor) and the window is blocked occupants can become trapped, posing a significant risk to life.

Figure 9. Access to windows obstructed by furniture (Deficiency No. BUH-FP-160226-067)
Source: DoD OIG

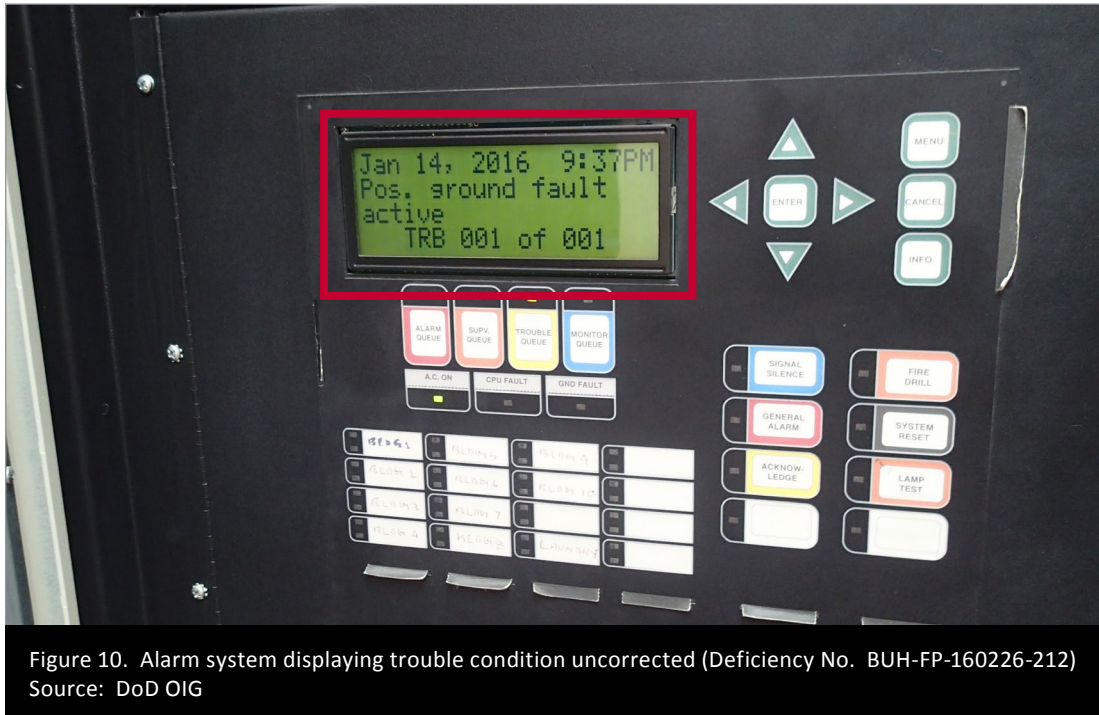
We found a Fire Alarm System (FAS) out of service without the required notification posted in all occupied rooms. When a FAS is out of service, the fire department must post notification in all occupied rooms in that building informing personnel that the fire alarm is incapable of sounding in the event of a fire. Also, we found two building

FASs with a “TRB” on the information panel indicating “trouble” conditions (Figure 10). Trouble condition notifications indicate operational issues with the system; these notices were active for 4 to 6 days without correction. This could cause significant delay in the fire department response to an emergency or fire.

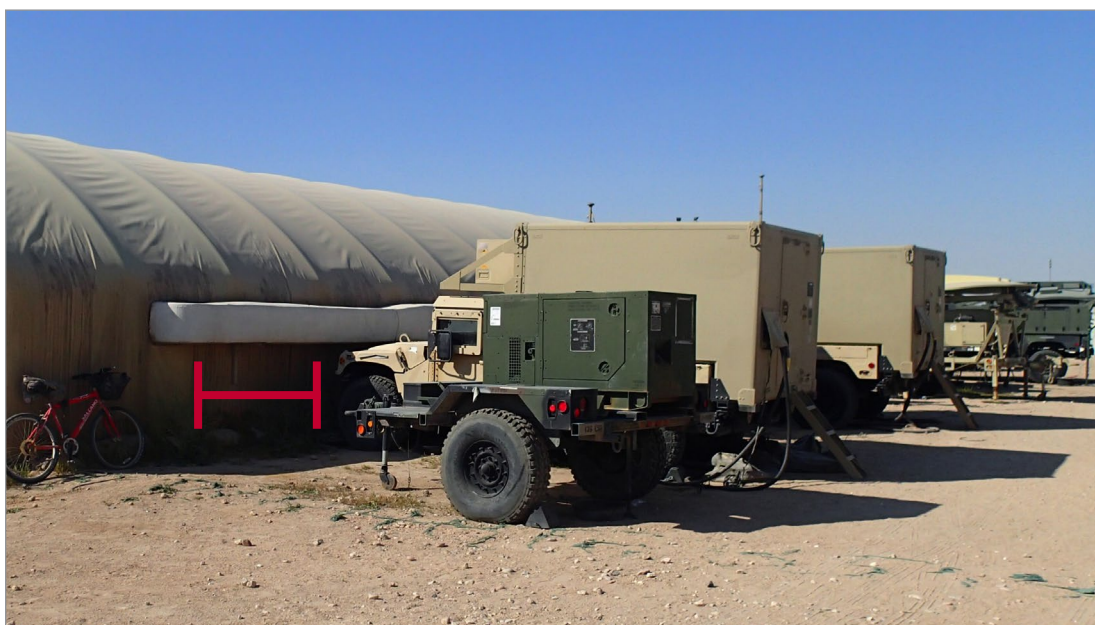
For fire prevention, we found that required clearance areas around buildings were obstructed by vehicles, storage, and vegetation. According to the UFC fire protection regulation, 30 feet of clearance is required between the building and the parking zone. We found vehicles parked within building separation zones (Figure 11). We also found inadequate separation between tent structures, and between housing and non-housing structures. Storage of combustible materials, or parking of vehicles too close to structures presents a risk of exposure to fire should the materials or vehicles ignite. They also obstruct firefighting equipment and personnel, and can delay or prevent the firefighter's response in the event of fire. These conditions increase unsafe and hazardous conditions.

Figure 11. Vehicles parked in a building clearance area in violation of fire prevention policy (Deficiency No. BUH-FP-160226-077)
Source: DoD OIG
